Allision of the Passenger Vessel *Seastreak Wall Street*  
with Pier 11, Lower Manhattan,  
New York, New York  
January 9, 2013

**Marine Accident Report**

NTSB/MAR-14/01  
PB2014-105712

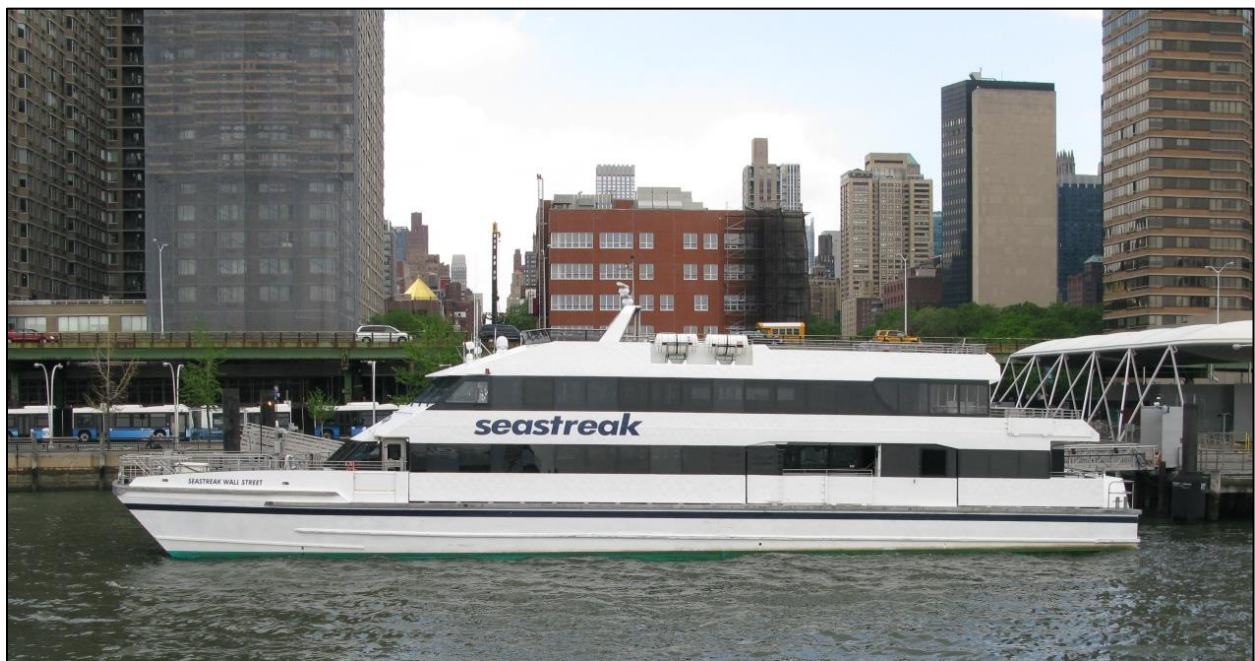
Figure 1. *Seastreak Wall Street*.

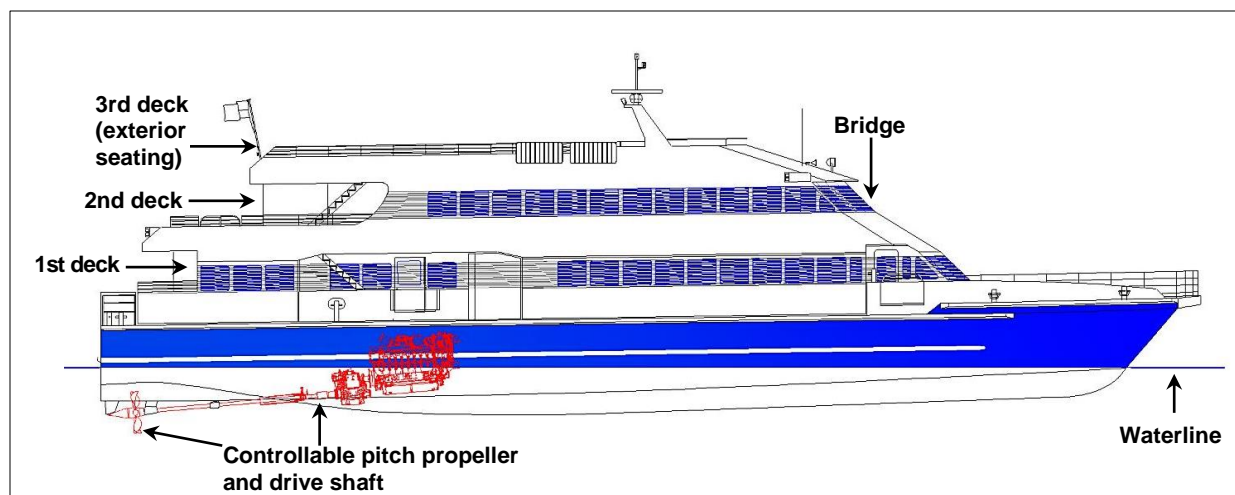
**Figure 9.** Profile view of the *Seastreak Wall Street* indicating deck levels and location of the bridge. The vessel's controllable pitch propulsion system is highlighted in red from the engine to the propeller. (Vessel drawing provided by Seastreak)

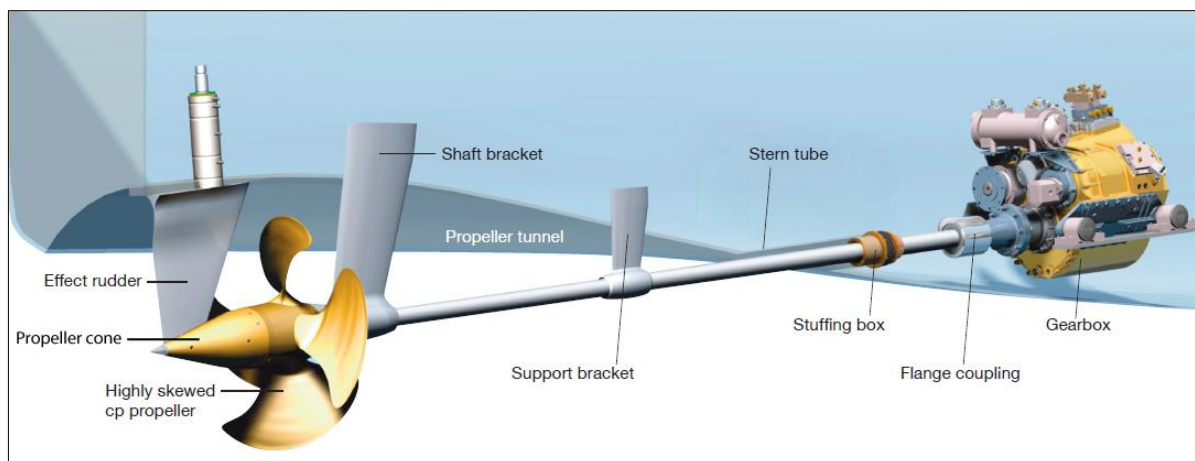
An independent diesel propulsion system, manufactured by Servogear AS of Norway, was fitted in the aft section of each of the two hulls, port and starboard, and each diesel engine drove a controllable pitch propeller (CPP). Except for the main engines, Servogear designed, built, and supplied the propulsion system as the Servogear Ecoflow Propulsor™ package, promoted as providing higher efficiency, lower fuel consumption, more economical operation, and less pollution. Figure 10 depicts the components of the Ecoflow Propulsor. Control systems for the vessel's propulsion and steering were manufactured by Scana Mar-El AS, a subcontractor to Servogear.

**Figure 10.** Servogear Ecoflow Propulsor system components. (Schematic drawing by Servogear)

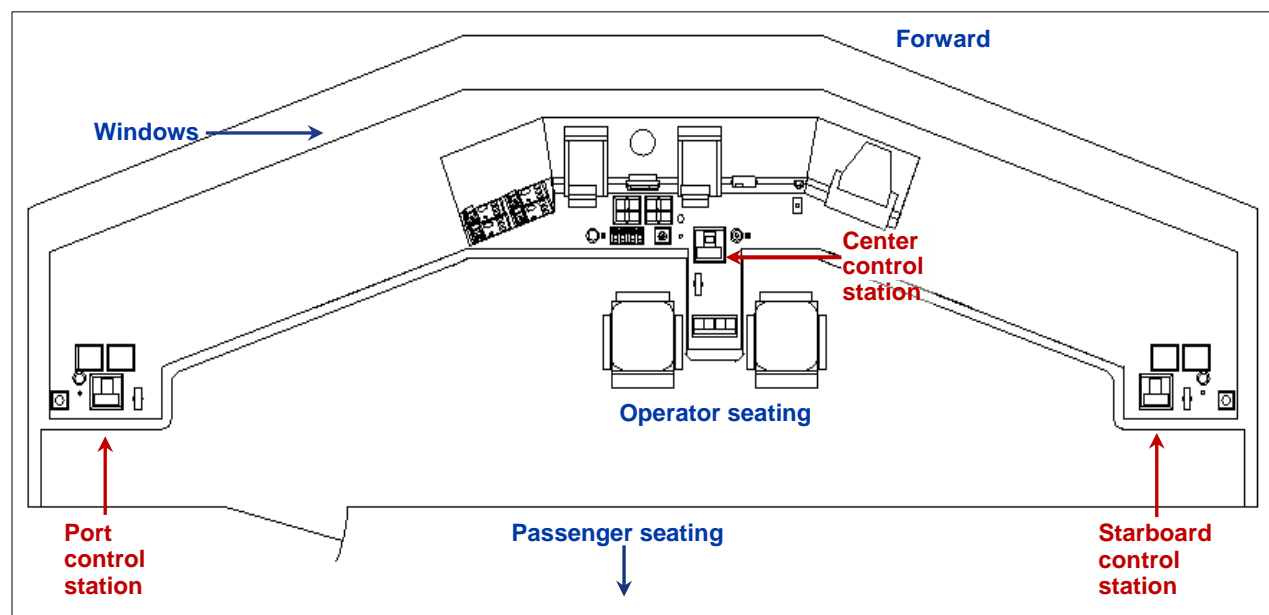
**Figure 11.** Simple schematic of *Seastreak Wall Street's* bridge indicating center, port, and starboard control stations (details not identical to those of the ferry as constructed). The bridge is 34 feet wide. (Drawing excerpted from *Seastreak* vessel plan)

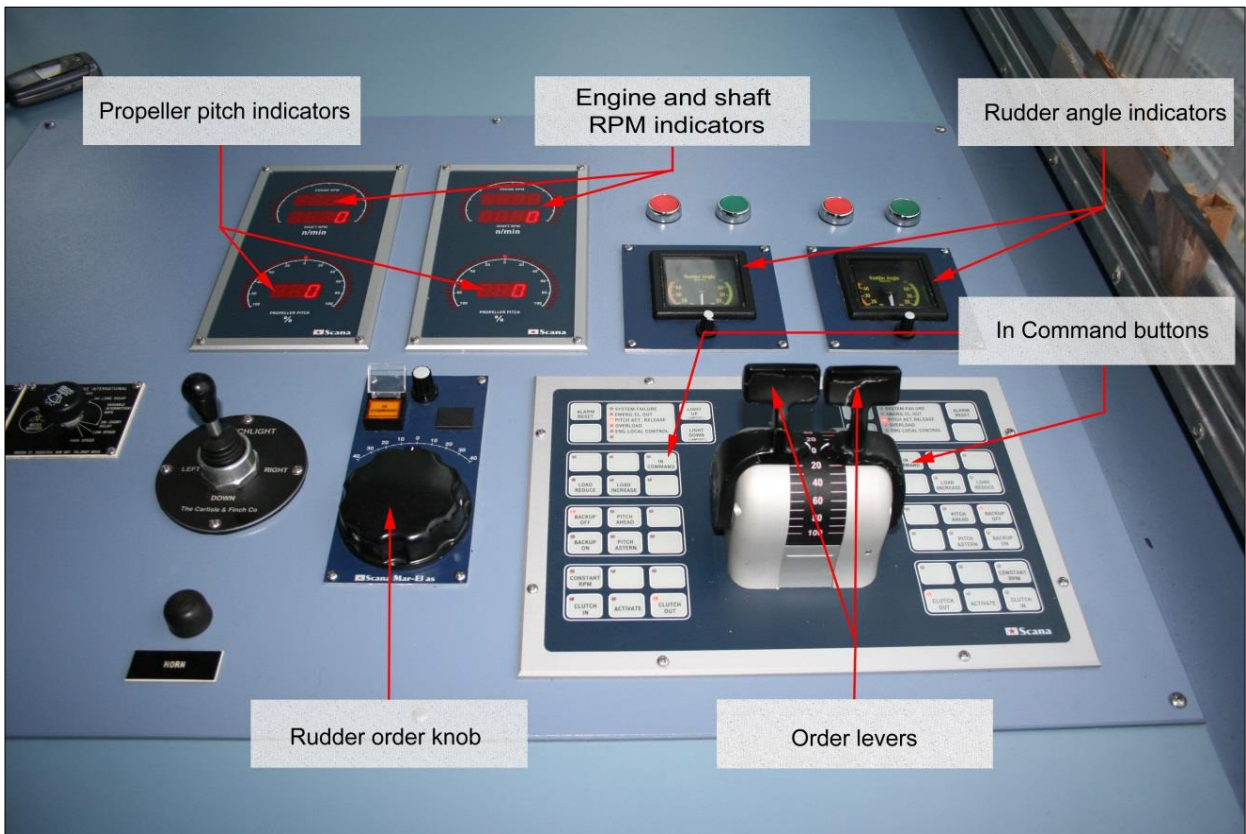
The three bridge control stations were the primary operator interfaces with the propulsion and steering control systems. They were identical in design and layout, and each had all the necessary components to monitor and control the engine rpm and propeller pitch for both starboard and port propulsion systems. Each station included controls for both propulsion systems, port and starboard: two order levers, two button and alarm indicator panels located on

either side of the order levers, two analog rudder angle indicators, two digital propeller pitch indicators, and two main propulsion engine and propeller shaft rpm indicators (see figure 12).

**Figure 12.** Photo of bridge control panel showing order levers, pushbutton controls and alarm displays, and engine and propulsion controls and indicators.

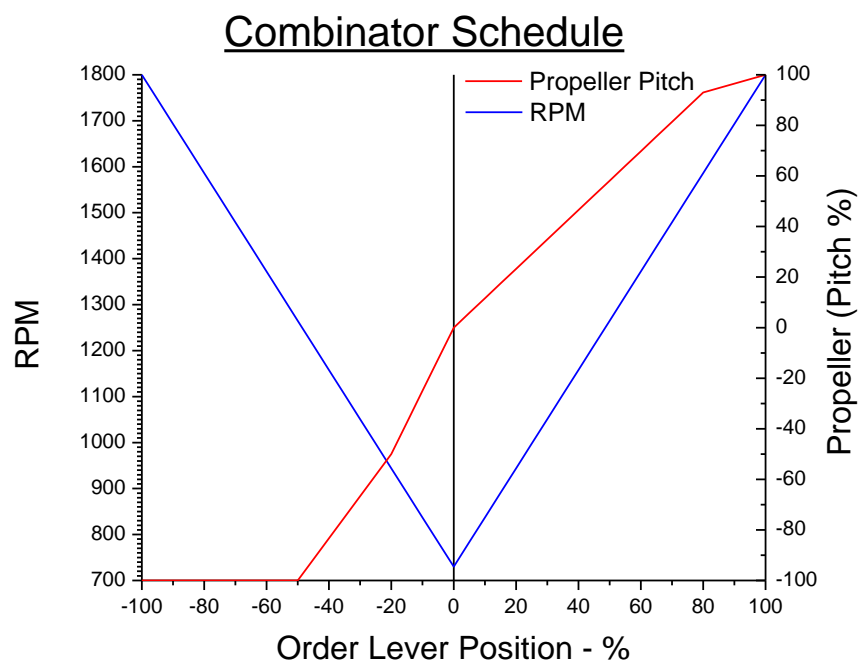
This power study was conducted to determine if the accident data were consistent with operation in Combinator mode or Backup mode. The ferry's propulsion was normally controlled in Combinator mode, in which order lever position controlled propeller pitch and engine rpm, according to a predetermined schedule, as shown in figure C-1. In Backup mode, propeller pitch was controlled independently of the order lever, which controlled only the engine speed.

**Figure C-1.** Combinator mode schedule.

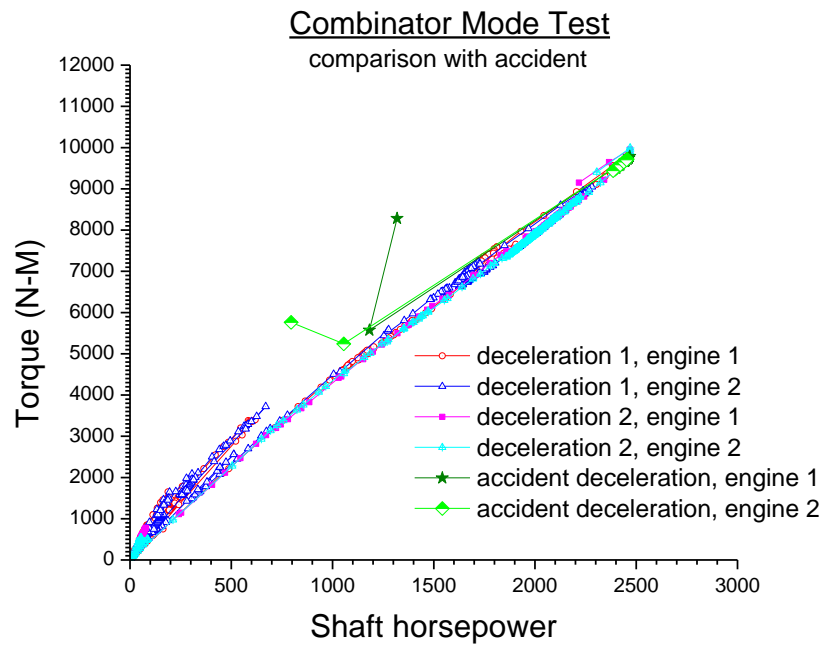
Figure C-2 shows torque as a function of shaft horsepower for two decelerations from 30 knots in Combinator mode.

**Figure C-2.** Torque versus shaft horsepower in Combinator mode.
